Manhole Inspection Summary

Manhole # S45GG_040MH

Insp Date: **3/13/08 10:14 AM**

Location Address: **Chester**

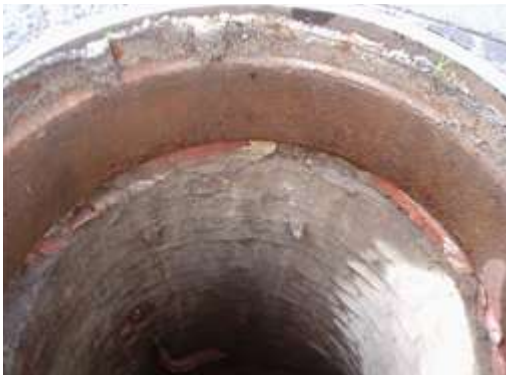
Defect 1

Condition: ☐ Sound ☐ Cracked ☐ Root Intrusion ☒ **Loose Brick** ☐ Deteriorated

loose bricks

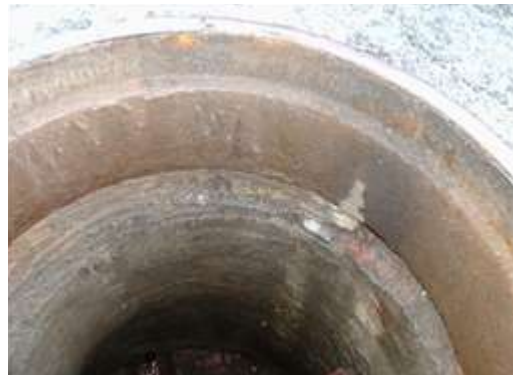
Defect 2

Frame Offset: **2** (in.) Condition: ☐ Sound ☐ Cracked ☒ **Leaks**

offset

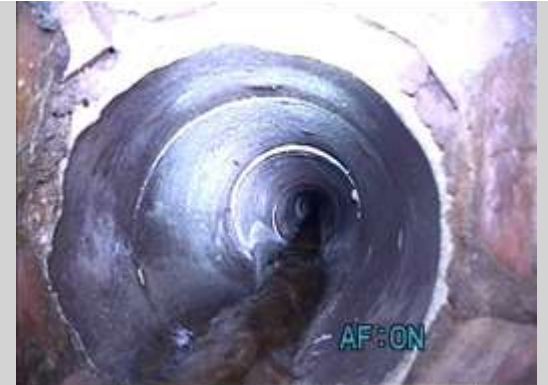
12 O'Clock Outflow

8 in. Circular Gravity Sewer
Pipe Out @ 12 O'Clock

Pipe Height: **8.4** (in.) Rod and Bar (Angled)
Pipe Material: **Clay** ☐ Pipe Lined
Invert Depth: **9.00** (ft.) Flow Characteristics: **Fast**
Deposits: ☒ None ☐ Mud ☐ Sludge ☐ Debris ☐ Grease
Silt Depth: (in.) Deposits Extent:
Infiltration: **None** Pipe Seal Cond: **Cracked**

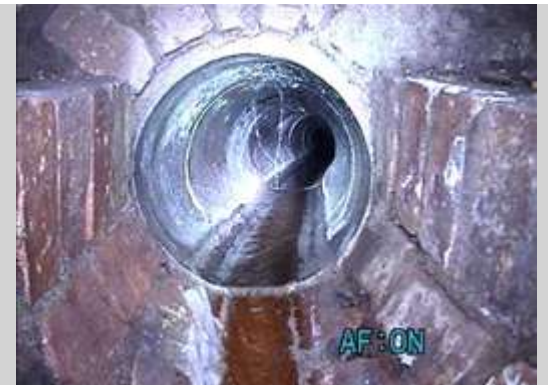
9 O'Clock Inflow

8 in. Circular Gravity Sewer
Pipe In @ 9 O'Clock

Pipe Height: **8.4** (in.) Rod and Bar (Angled)
Pipe Material: **Clay** ☐ Pipe Lined
Invert Depth: **8.40** (ft.) Flow Characteristics: **Fast**
Deposits: ☒ None ☐ Mud ☐ Sludge ☐ Debris ☐ Grease
Silt Depth: (in.) Deposits Extent:
Infiltration: **None** Pipe Seal Cond: **Cracked**
